TECHNICAL SERVICE BULLETIN

Part #:	VAR-01012017	Engine:	6.0L Powerstroke & VT365 Navistar
Date:	01/14/2021	Title:	6.0L Variation

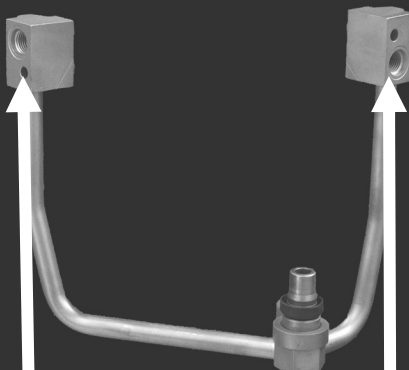
FIRST STYLE BRANCH

THREADED STAND PIPE CONNECTION PART #1840550C1
