TECHNICAL SERVICE BULLETIN

TSB #:	TSB-VAR117	ENGINE:	ALL 6.0L PRODUCTS
DATE:	01/17/2017	ISSUED BY:	SERVICE

6.0 LITER VARIATIONS

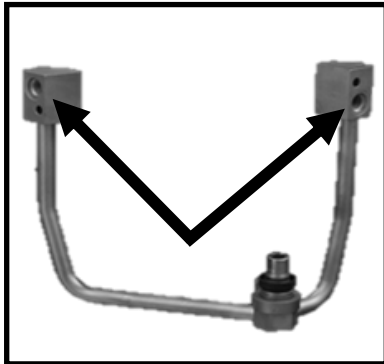
FIRST STYLE BRANCH TUBE

THREADED STAND PIPE CONNECTION WITH QUICK CONNECT OIL PUMP CONNECTION

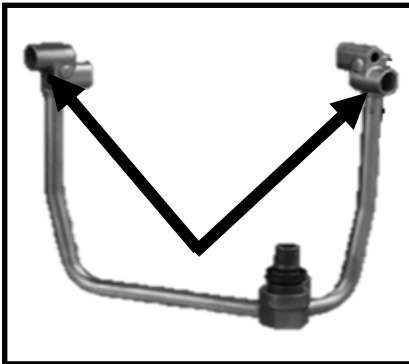
SECOND STYLE BRANCH

PRESS IN O-RING CONNECTION WITH QUICK CONNECT OIL PUMP

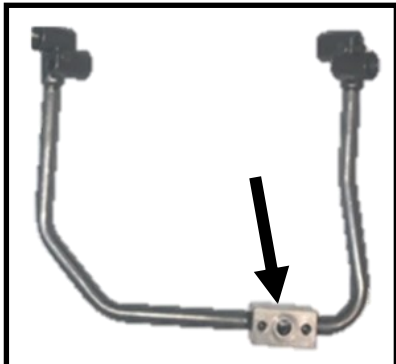
THIRD STYLE BRANCH TUBE

PRESS IN O-RING CONNECTION WITH NEW STYLE FUEL TUBE CONNECTION

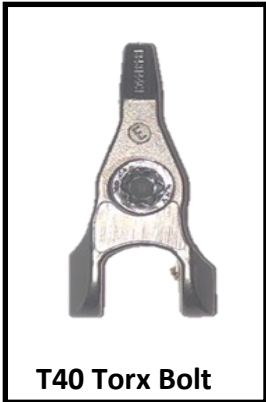
1st STYLE INJECTOR CLAMP

T40 Torx Bolt

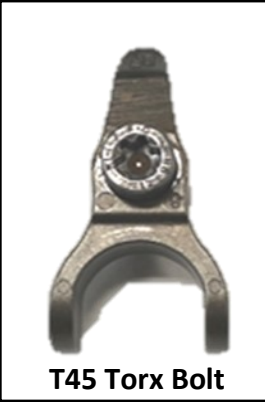
2nd STYLE INJECTOR CLAMP

T45 Torx Bolt

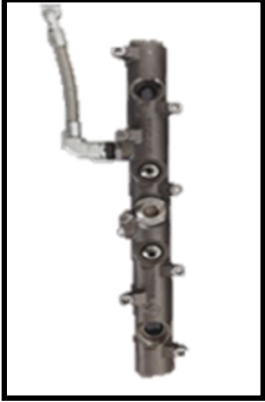
1st STYLE OIL MANIFOLD

THE FIRST STYLE OIL MANIFOLD ONLY BOLTS CORRECTLY ONTO THE ROCKER BOX PART # 1840550C1

PART# 1838901C3, 1838901C4 & OTHERS COMPATIBLE WITH ROCKER BOXES # 1840550C1 (1ST) 1843351C2 (2ND) 1843351C3 (3RD)

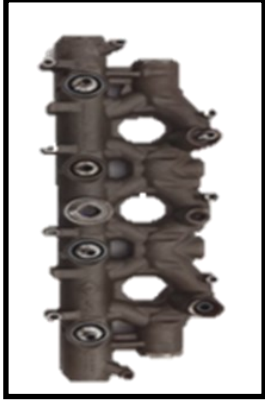
2nd STYLE OIL MANIFOLD

THE SECOND STYLE OIL MANIFOLD BOLTS ONTO THE ROCKER BOX PART # 1843351C2, 1843351C3, & 1858473C1

PART# 1856237C1 & OTHERS COMPATIBLE WITH ROCKER BOX # 1858473C1 (4TH)
